Review of previously alleged unauthorised works to foreshore and investigations by the Local Planning Authority

Land at Dolphins, Rookwood Lane, West Wittering

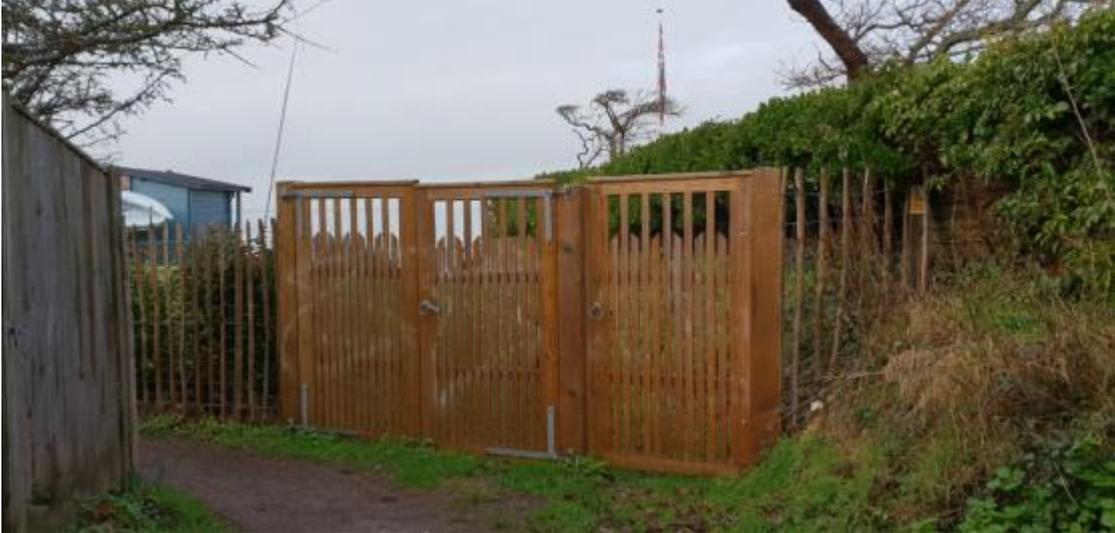
- 2.2 Replacement gates and chestnut paling fencing were erected to the eastern boundary of the foreshore land in 2017. A PROW runs adjacent to the boundary and the area in which the gates are located provides an access point from the PROW to the foreshore. The land is within private ownership and the access to the foreshore does not form part of the PROW.

Photo 1 [CDC Officer]: View of gates and fencing from public right of way (07/11/2018)

- 2.5 Notwithstanding the above conclusion in relation to the impact of the European designated sites, the gates are constructed from timber and are of a louvered vertical design set within a wooden frame. The combination of the framing with the bulk of the timber posts and heavy duty hinges is considered

to have a detrimental impact on the visual amenity of the AONB due to their overbearing appearance being in a prominent position along the PROW.

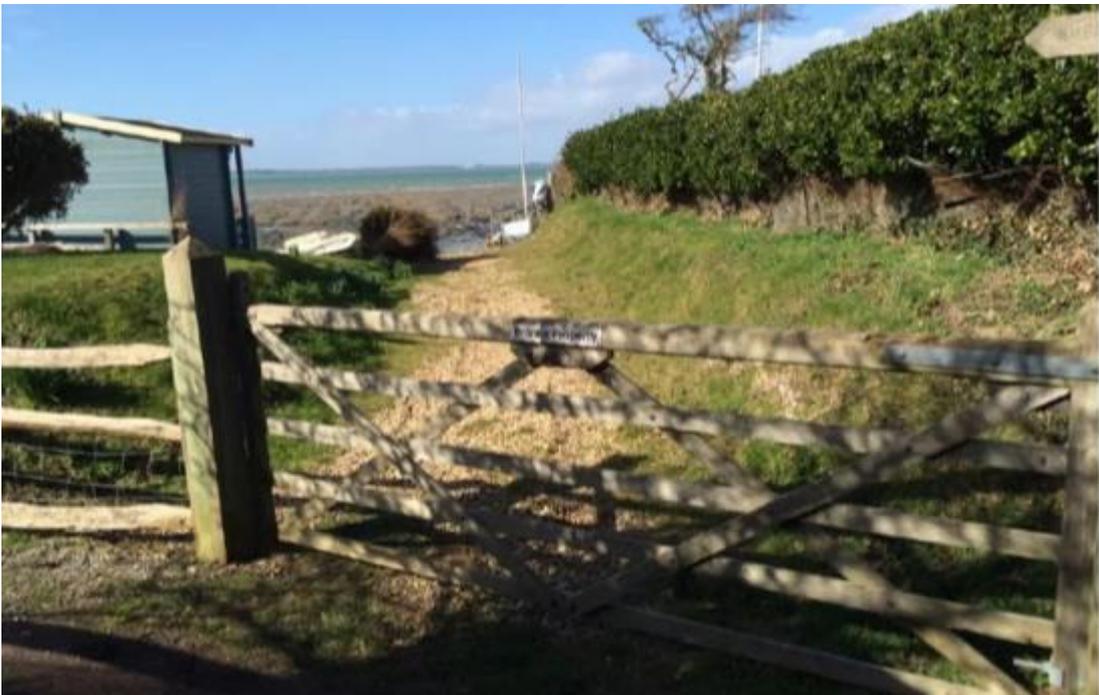
Photo 2 [Third party]: Previous gate and fence (circa 2011/2012)

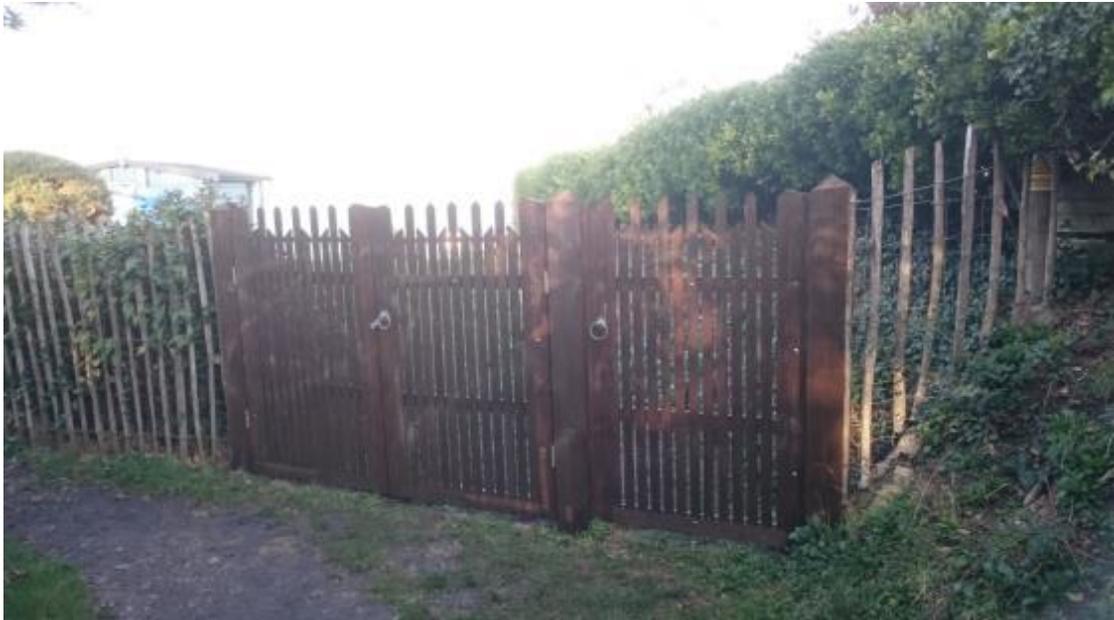
Photo 3 [Landowner]: View of amended gates and fencing from public right of way (10/10/2019)

- 2.6 Given identified landscape harm that the gates presented to the AONB it was considered important for the LPA to attempt to negotiate further works to mitigate this impact. As such the owner was requested to undertake remedial works to the gates lowering the height of the gates to a similar level to that of the adjoining paling fence, in order to reduce the impact on the visual amenities of the area to an acceptable level.
- 2.7 These steps were carried out, including re-positioning the metal hinges to the inside of the gates and applying a dark stain, as shown in the photograph below:

- 2.8 It is considered by the Local Planning Authority that planning permission would not have been required for the gates, nonetheless, remedial works have reduced the detrimental impact on the visual amenity of the area and no further action can be taken.

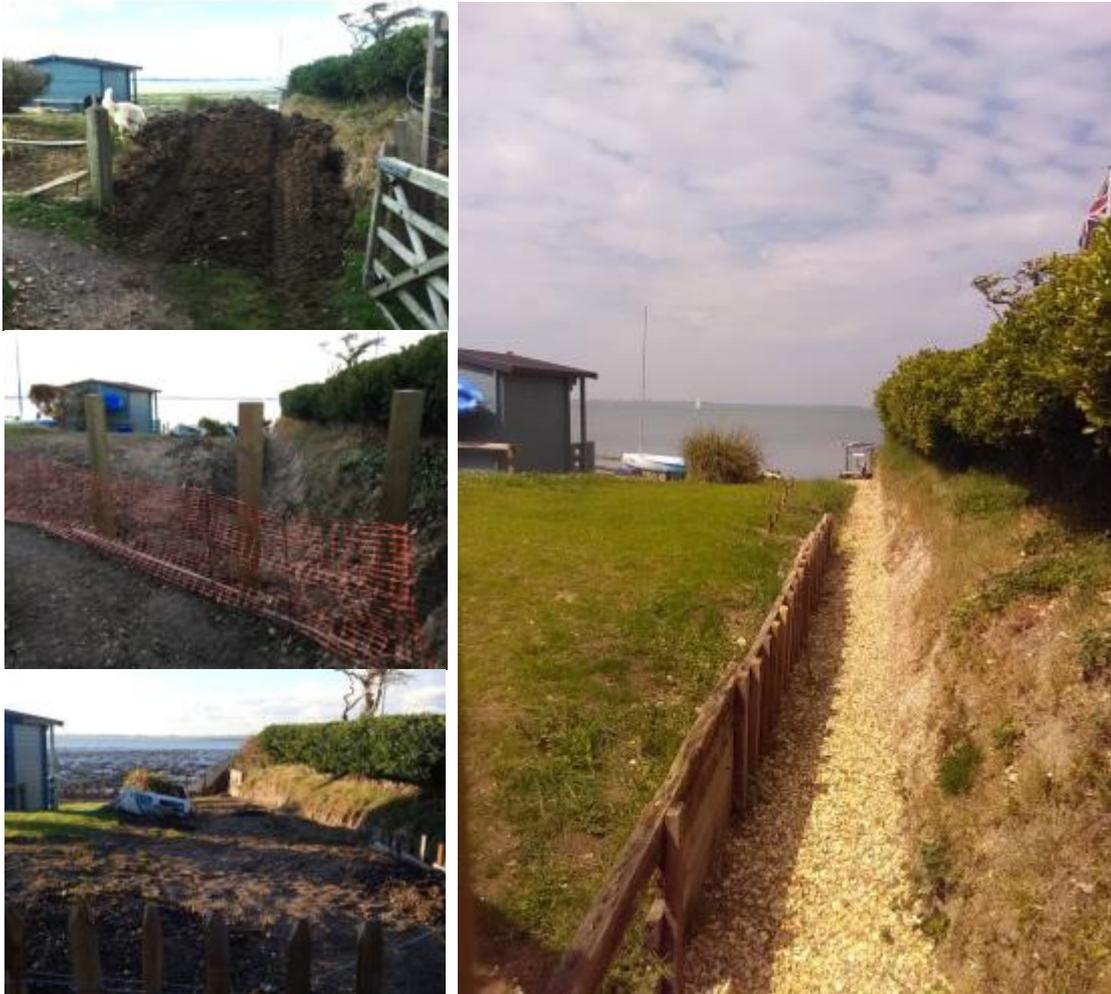
- 2.9 Engineering works were carried out in 2017 to import soil onto the foreshore land. The soil was spread over the area of the shingle track/path to raise and level this area of the ground; resulting in the made path being reduced to a narrow pedestrian track beside the boundary hedge. Timber planks retain the soil along the track. These works were carried out immediately prior to the gates being erected.

2.10 The importation of the soil and the scale of engineering works to landscape the area are beyond what could be considered to be de minimis and no permitted development rights exist for such an operation. When officers enquired about these works, the owner advised the soil had been imported from a source 100m from the foreshore land i.e. from neighbouring land.

Photos 4-7 [Third party]: View of the soil importation, from the PROW (2017)

- 2.15 Based on these comments, it is concluded that the engineering works consisting of importing the soil and landscaping the area does not now result in lasting long-term significant harm to the local habitat. Any restorative action would likely have greater potential for further impact than leaving the imported soil in situ.
- 2.16 With regard to the impact of the imported soil on the visual amenities of the area, the soil was grass seeded which has now established to blend in with the rest of the land. In addition, the area of raised ground is relatively small and follows the form of the existing land level and so appears natural in the context of its immediate surroundings. Now that the soil has been compacted and landscaped it derives a similar appearance to the land surrounding it. It is

therefore considered that the works carried out have not had a detrimental impact on the visual amenity of the AONB and not “incongruous”. In addition the timber retaining ‘wall’ is sympathetic to the sensitive location and will naturally weather into the landscape of the harbour.

2.17 No further action is proposed by the Local Planning Authority in respect of these works as it would not be expedient to do so having regard to the provisions of the development plan and advice received from Natural England.

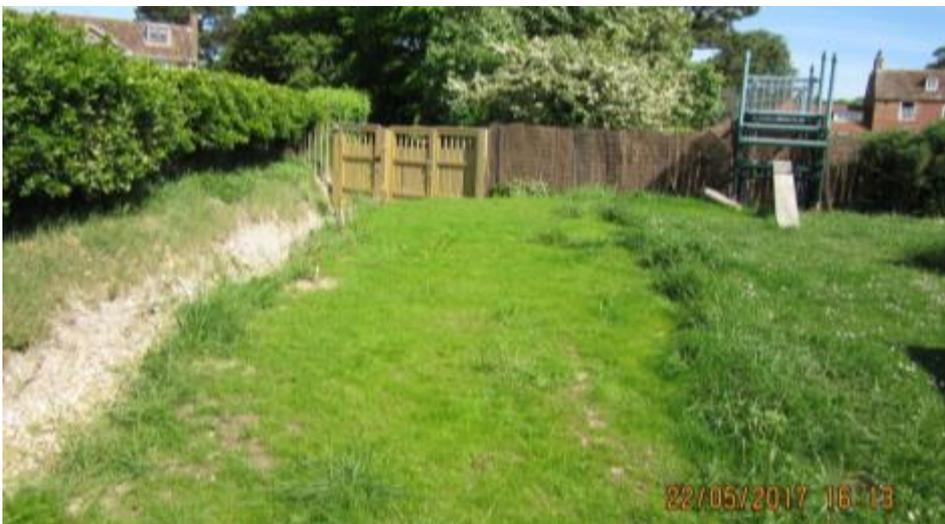
Photo 8 [CDC Officer]: View of the soil importation, from the shore (2017)

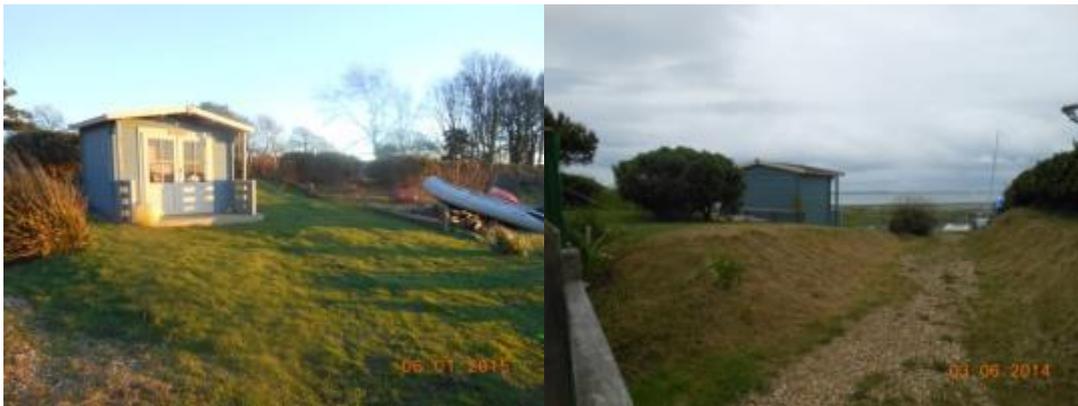
2.18 A beach hut/summerhouse style building has been previously erected on the foreshore land. The development was reported to the LPA on the 15 April 2014 and registered as an enforcement investigation case (reference 14/00108/CONHH). As a development on land outside the curtilage of the dwellinghouse, and in close proximity to the European designated sites, the structure would have necessitated the making of a planning application to the LPA, seeking planning permission.

Photos 9-10 [CDC Officer]: View of the structure from; the waters edge (left - 2015) and PROW (right – 2014)

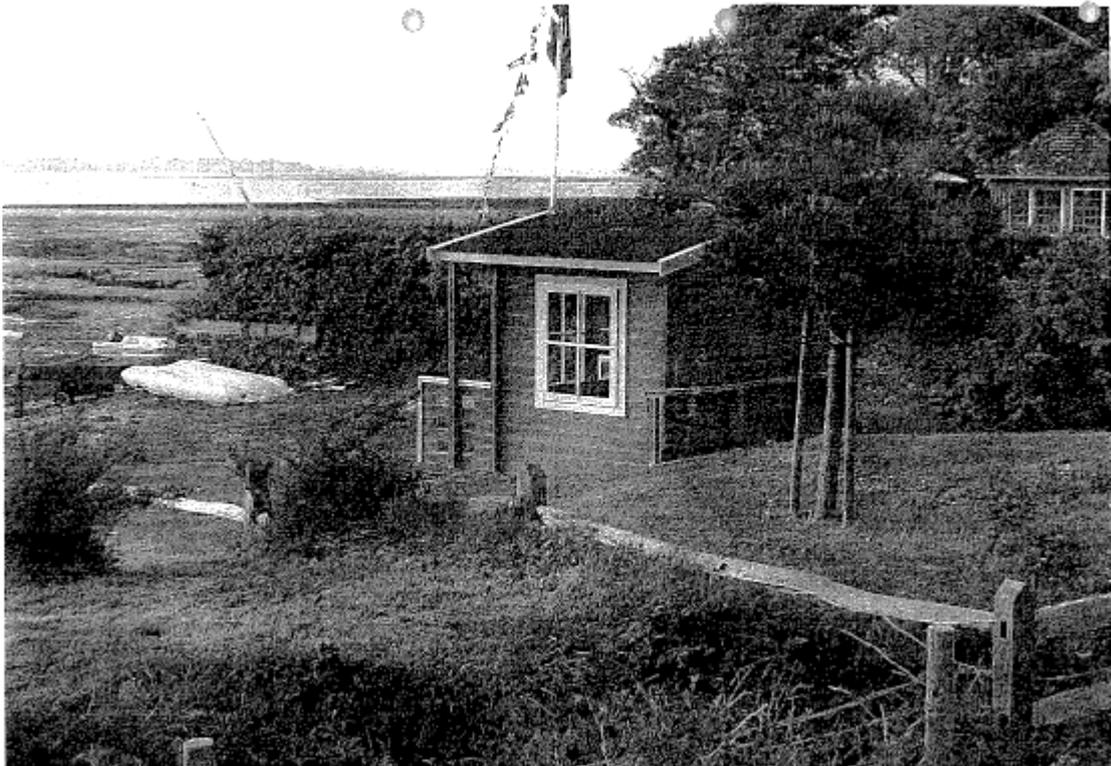
Photo 11 [Landowner]: Structure viewed from the PROW (29/04/2011)

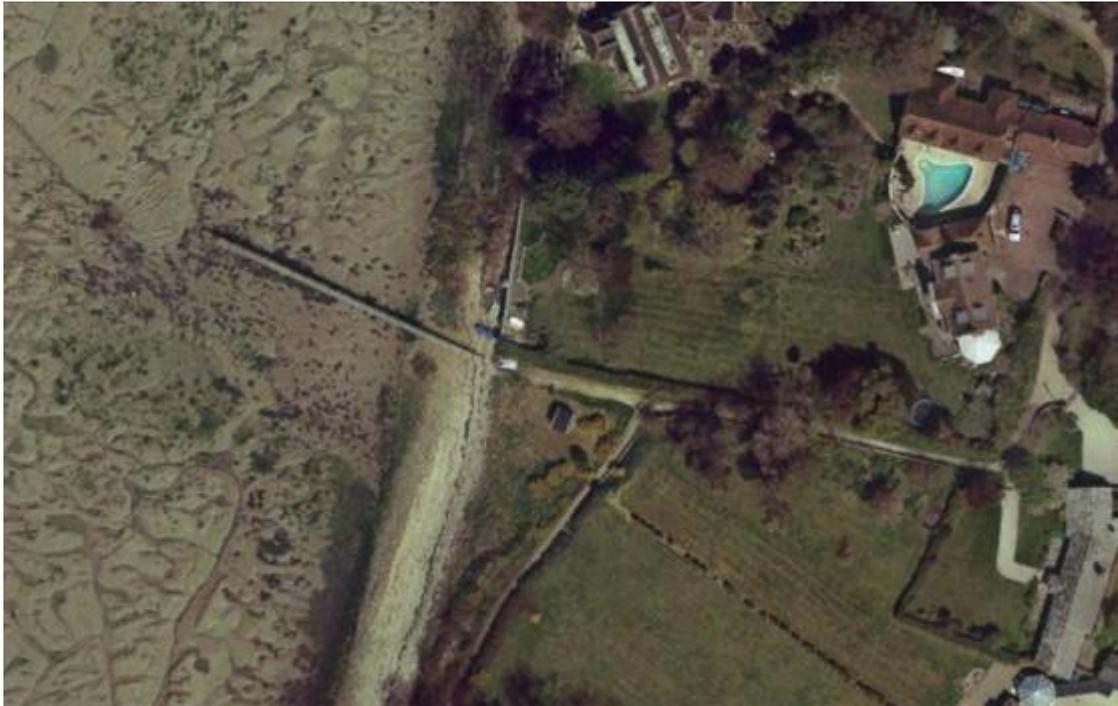
Aerial Photo 1 [CDC] (2013)

- 2.22 Notwithstanding the history of enforcement investigations on this site set out above, the LPA can only now take action on operational development which has occurred in the last 4 years. There is clear independent evidence that the 'beach hut' was substantially completed by 2013 as it appears, with a roof, on the 2013 aerial photograph held by CDC. See below:

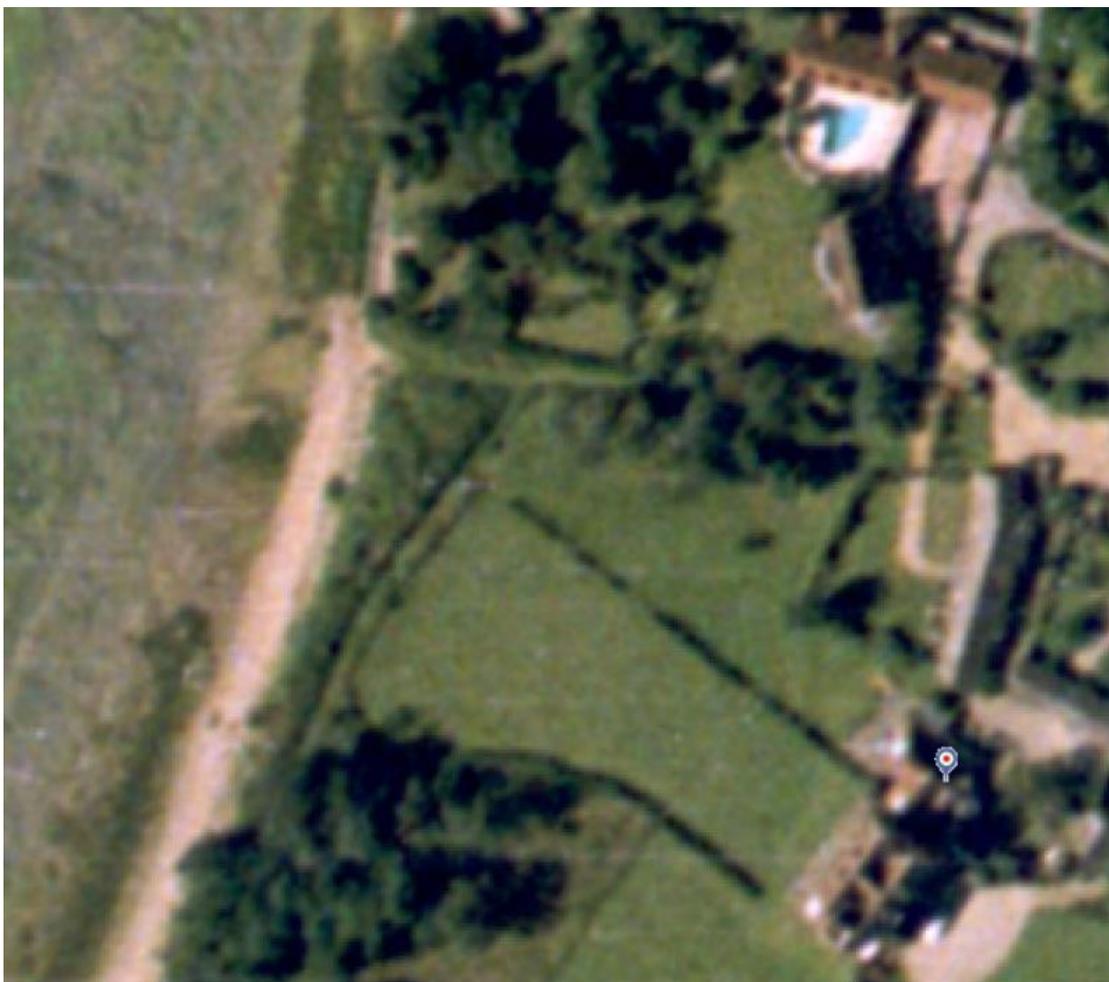
Aerial Photo 3 [CDC] (1991)

- 2.34 In the above image there is a clear difference in the way the land is managed between the foreshore land to the west of the footpath and the garden associated with Dolphins to the east. In the absence of any further evidence it is likely that the land was not used as 'garden land' in association with Dolphins, at that time. The nature of the vegetation is consistent across the length of the foreshore.

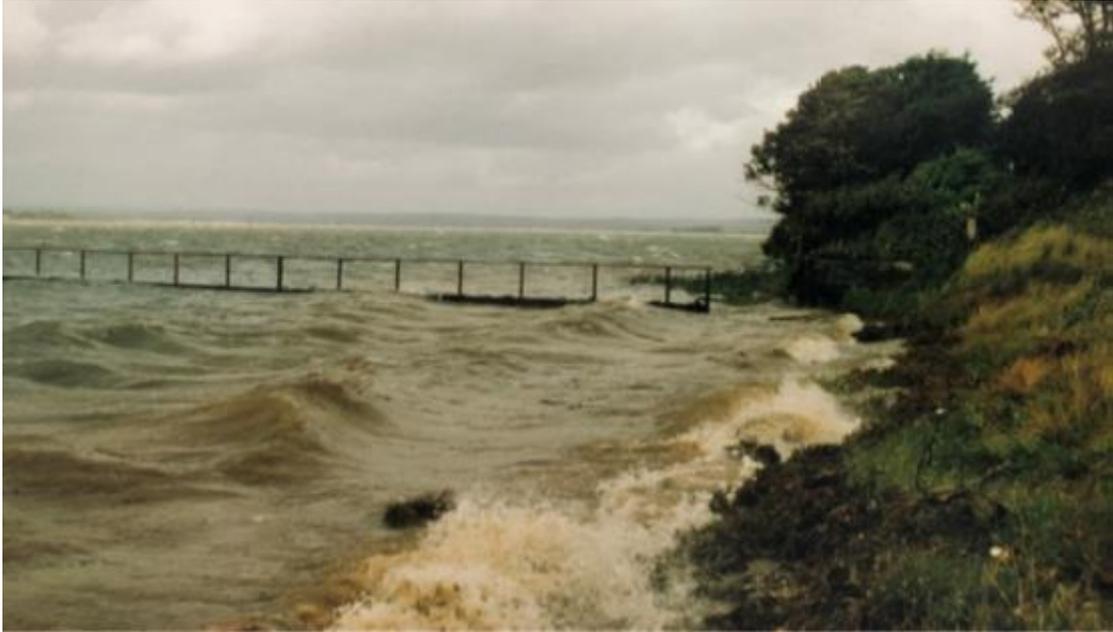
Photo 12 [Third Party]: Photograph of the foreshore, the land in question is in the foreground of the trees to the top right of the photo (1996)

- 2.35 Photograph 12 only shows the first few metres of the foreshore land, but it appears unkempt and not domesticated in any way. On the balance of probabilities it is unlikely that the land was used for any domestic purpose at this time.

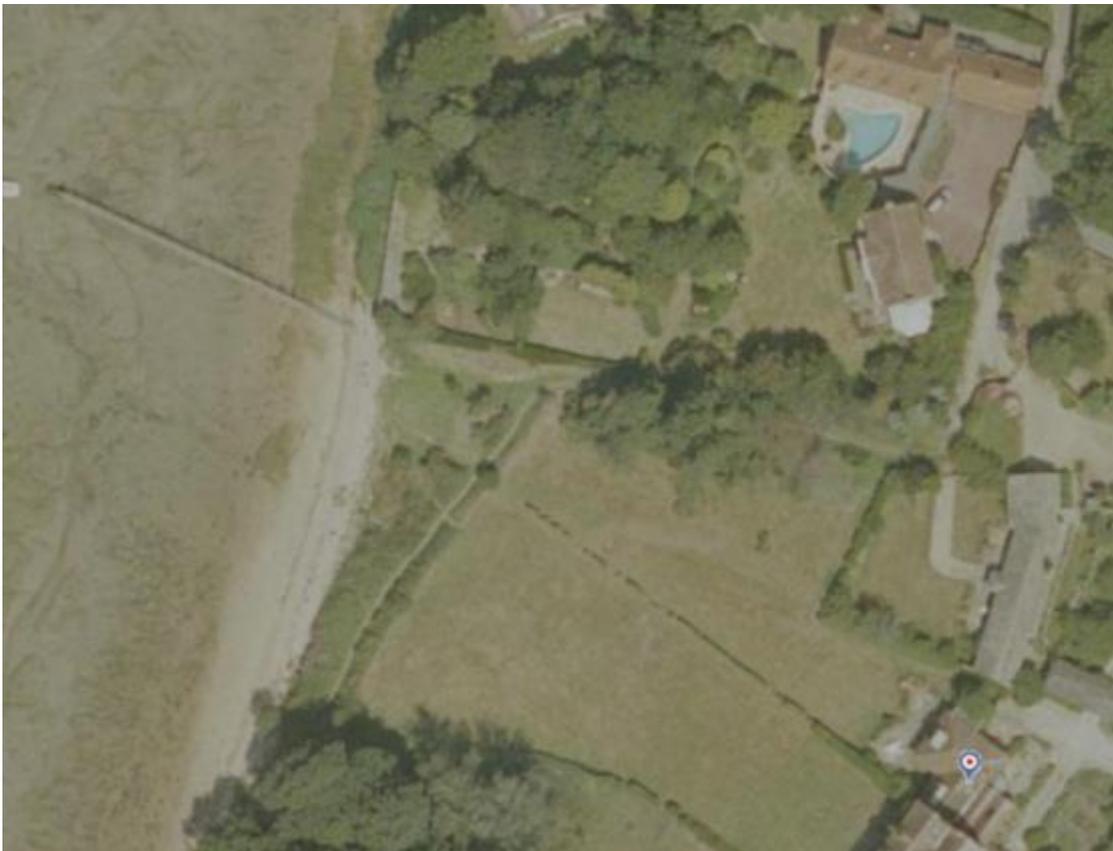
Aerial Photo 4 [CDC] (2001)

- 2.36 Aerial Photo 4 provides the first photographic evidence of a change in the way in which the land is being managed. The previous brush has been mostly cleared and the appearance of the land is evidently different to the part of the foreshore to the south in separate ownership.

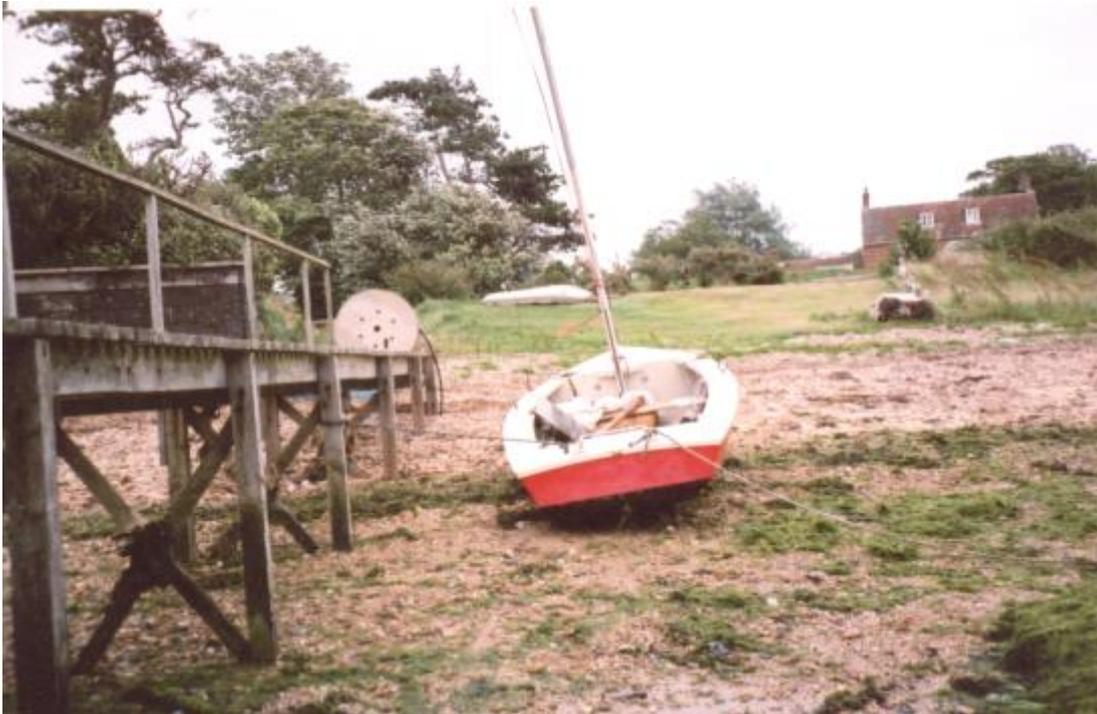
Photo 13 [Landowner]: Photograph of the foreshore during low tide, viewed from the waters edge (2004).

- 2.37 The above photo supports the conclusions regarding Aerial Photo 4. Much of the previous vegetation has clearly gone and there is a marked difference in the way the site looks to that of the neighbouring foreshore to the south (right of the photo), which is much more overgrown and in a more 'natural' and unmanaged state. Whilst no human activity is taking place in the photo the land is being used for the storage of boats and there is a cable reel visible, presumably from the installation of the services connection to the main house that occurred around that time.

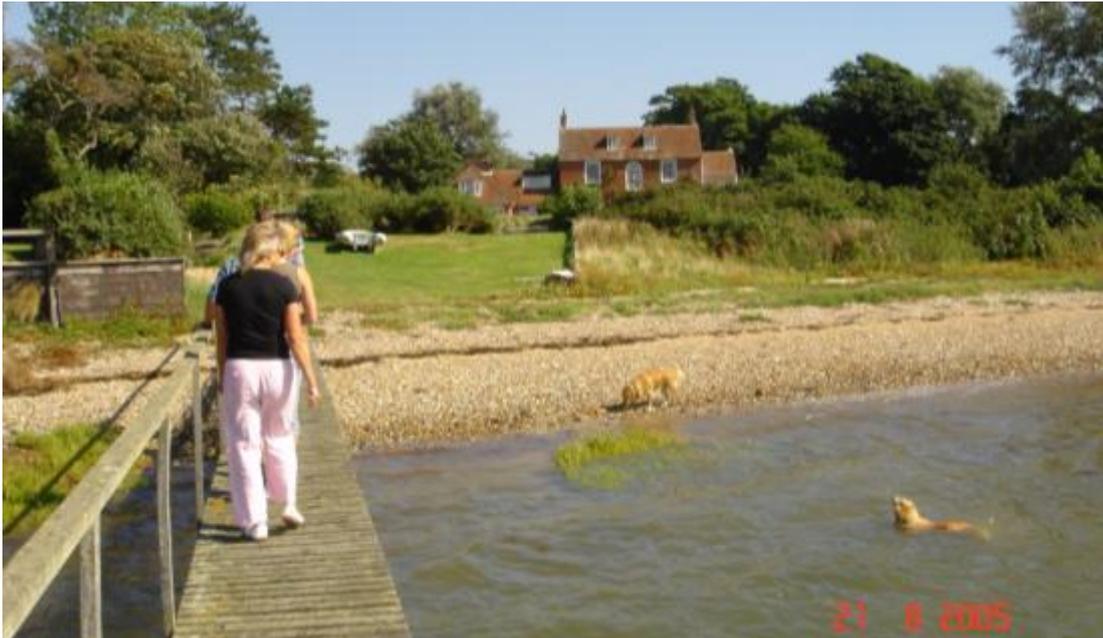
Photo 14 [Landowner]: Photograph of the foreshore, viewed from Jetty (2005)

- 2.38 The photo above clearly shows the triangular foreshore land which visibly appears more tended and manicured appearance, starkly different to the foreshore to the south (right of the photo). The image also shows some use of the land for private recreational purposes/dog walking.

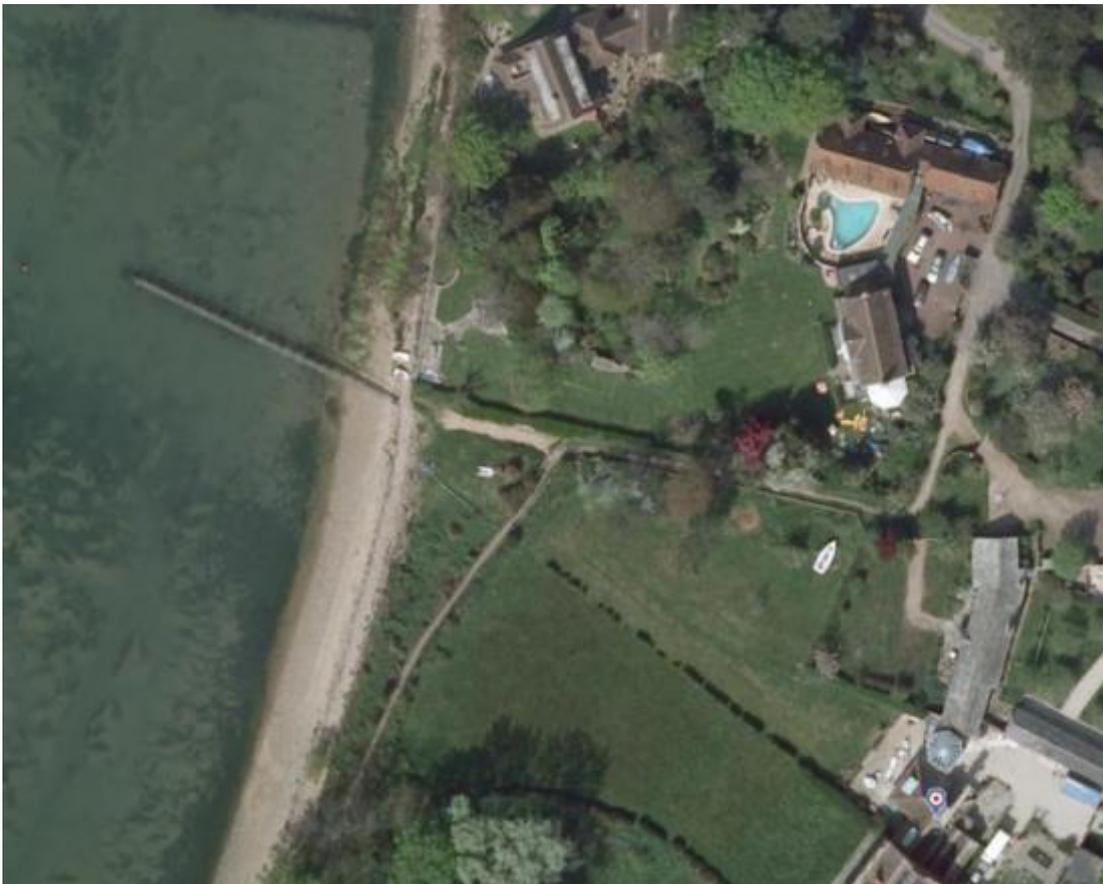
Aerial Photo 5 [CDC] (2007)

2.39 Aerial photo 5 further supports the preceding landowner's photo. The land takes on a similar appearance to the curtilage of Dolphins and it is reasonable to assume that the grass continues to be maintained in a manner that is consistent with recreational 'garden use'. Third parties have reported using the land in 2007 for a party of 30 people, hiring kayaks for a local event and using the land to provide access to the sea for boating activities. Whilst no substantive evidence to support this claim has been submitted it is considered that the use described supports the owner's contention that this is garden land; and that the garden has been used for private recreational activities consistent with other parcels of private land that adjoin the waters edge within the fingers of Chichester Harbour.

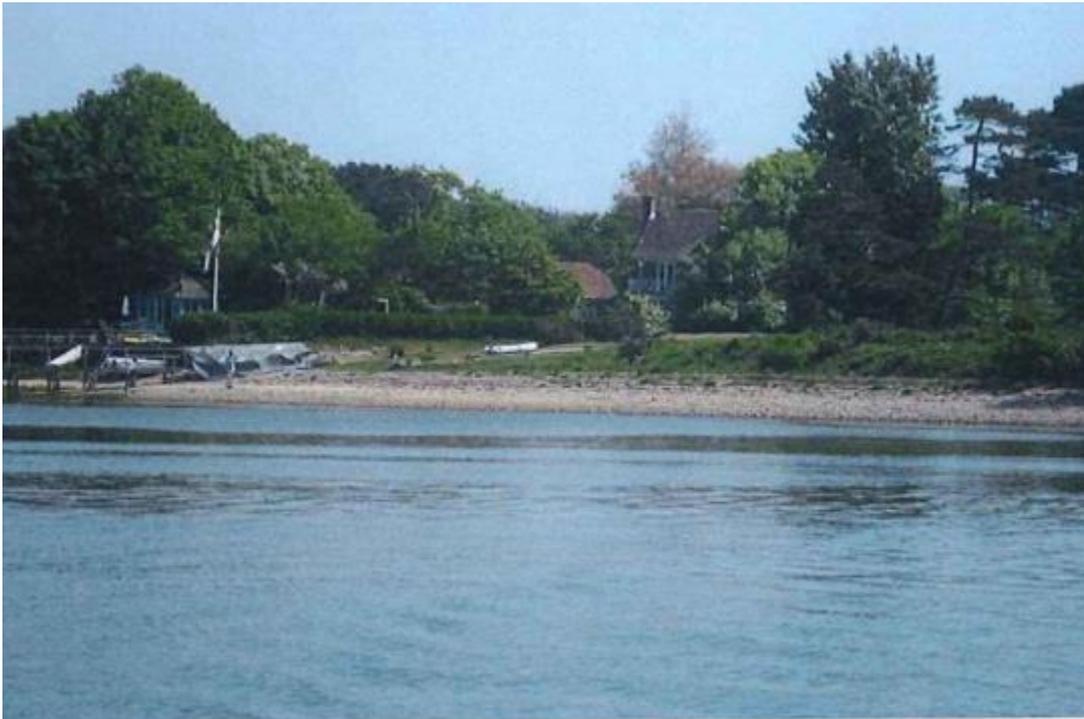
Photo 15 [Third Party]: Photo of the foreshore, viewed from the water (2010)

2.40 The above photograph has been presented to the LPA as it is considered to demonstrate that the land was in an unmanaged state in May 2010. To the contrary the photograph is taken at such an angle that the 'unmanaged' foreshore in the foreground is that of the area of foreshore to the south in another ownership. It is considered that the image shows cultivation and management of the land; in particular, there is a low level post and rail fence visible along the boundary between the two areas of foreshore and there is nothing to suggest that the grass on northern part of the foreshore is not managed in the same way as shown in photos 13 (2004) and 14 (2005). This is supported by Aerial Photo 6 (dated 7th October 2010), which shows the outline of what is likely to be the boat shown in Photo 15. It is clear that at on this date there was no building on the land.

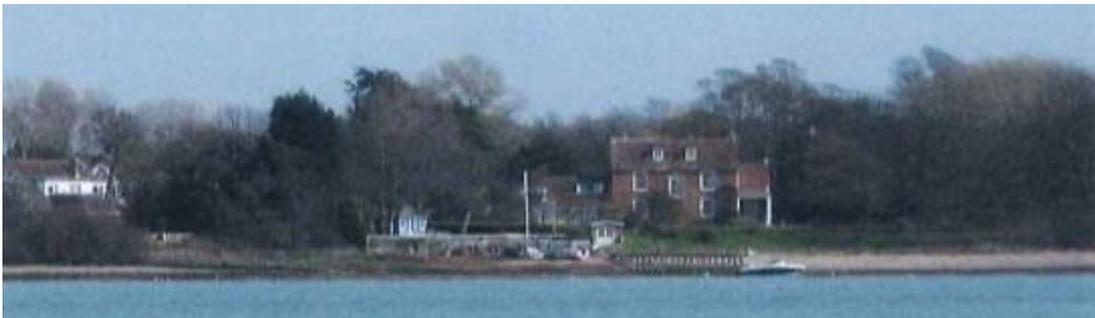
Photo 16 [Third Party]: Photo of the foreshore, from the water (13/04/2012)

- 2.41 The above photo is not clear enough to determine whether the ground continues to be managed in the same manicured way as previously shown. However it us the first 'ground level' photo of the 'beach hut'/shed which indicates that a domestic level of use continued. The aerial photo below indicates the continued and keeping of the land in a manner similar to that previously. It is the first aerial photo which shows the building on the land. The foreshore to the south appears to have been the subject of some clearance of brush, although the photograph suggests the grass is not maintained in the same manicured way as the northern section of foreshore.

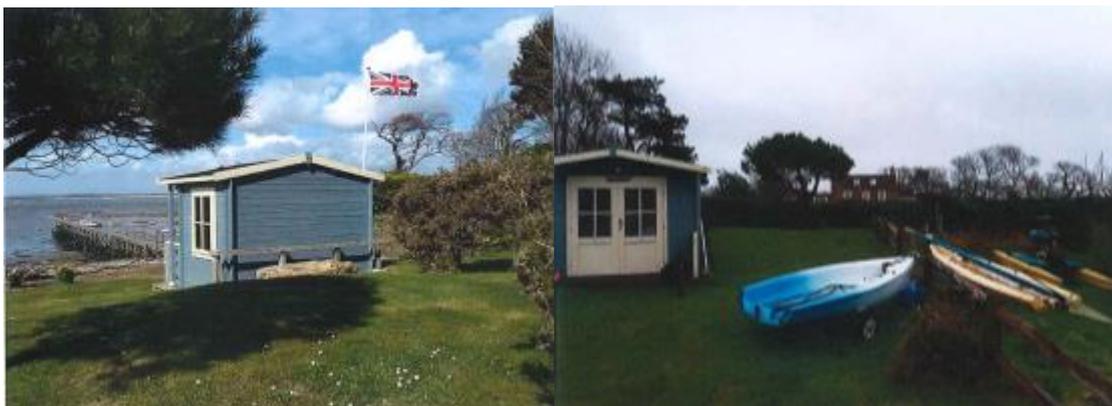
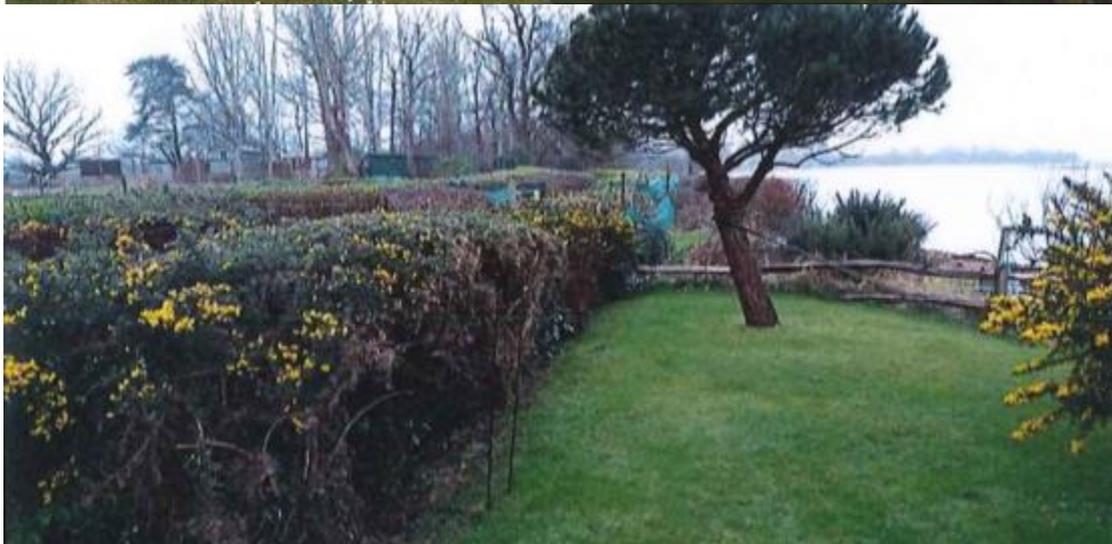
Photos 17-19 [Third Party]: Photos of the foreshore (13/02/2018)

2.42 More recent photographs in 2018 (below demonstrate the continued keeping of the land in a domestic manner, which would suggest a similarly conferred use.

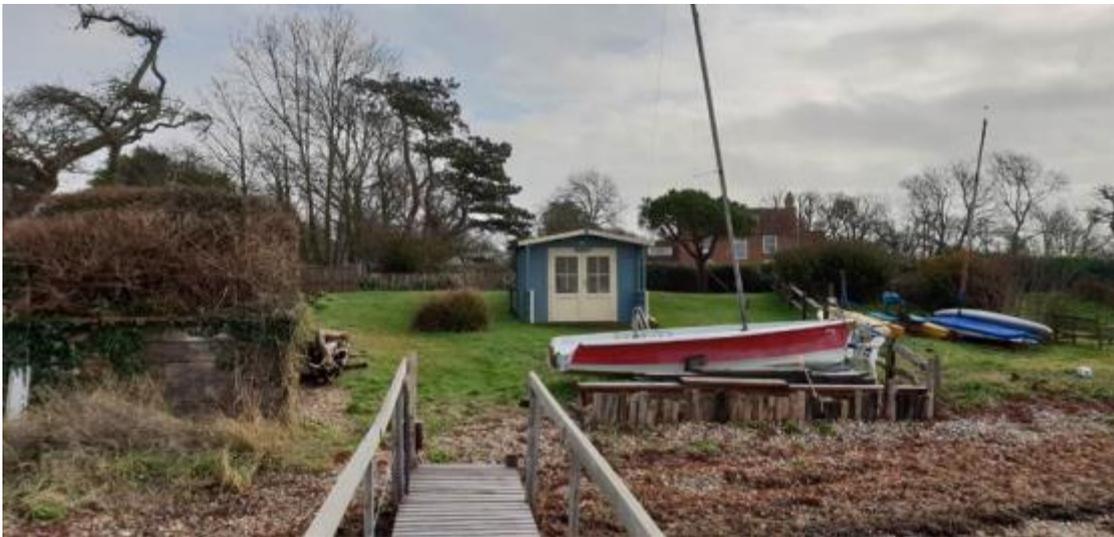
Photo 20 [CDC Officer]: Photo of the foreshore from the jetty (07/11/2018)

- 2.45 The most recent photo above reinforces the evidence before the LPA with regard to the previously demonstrated use of the land. It is a matter of record that the triangular foreshore section of land was formed when the position of the footpath was moved and that the land has had varying degrees of vegetation upon it over the subsequent years. Aerial photographs show that the land has had a different character to the neighbouring foreshore land as a result of grass cutting and this notable difference has been present for decades. Whilst it is apparent that the land was 'wilder' in character up until the late 1990s the appearance of the land does not mean that it was not used as a garden. Garden land does not need to conform to a 'norm' and can be uncultivated in nature. Since the late 1990s the land has been manicured and the garden use became more apparent, under the control of the new landowner, and consistent with that of other land connected to a residential property adjoining the shoreline. In addition to the above photographs a number of statutory declarations and correspondence has been received, setting out how third parties have observed/used the land over the past 10 years. Nothing detailed within these documents outweighs the evidence
